Cup Run (Snowshoe Mountain Resort property)

Estimated techniques and units for Cup Run

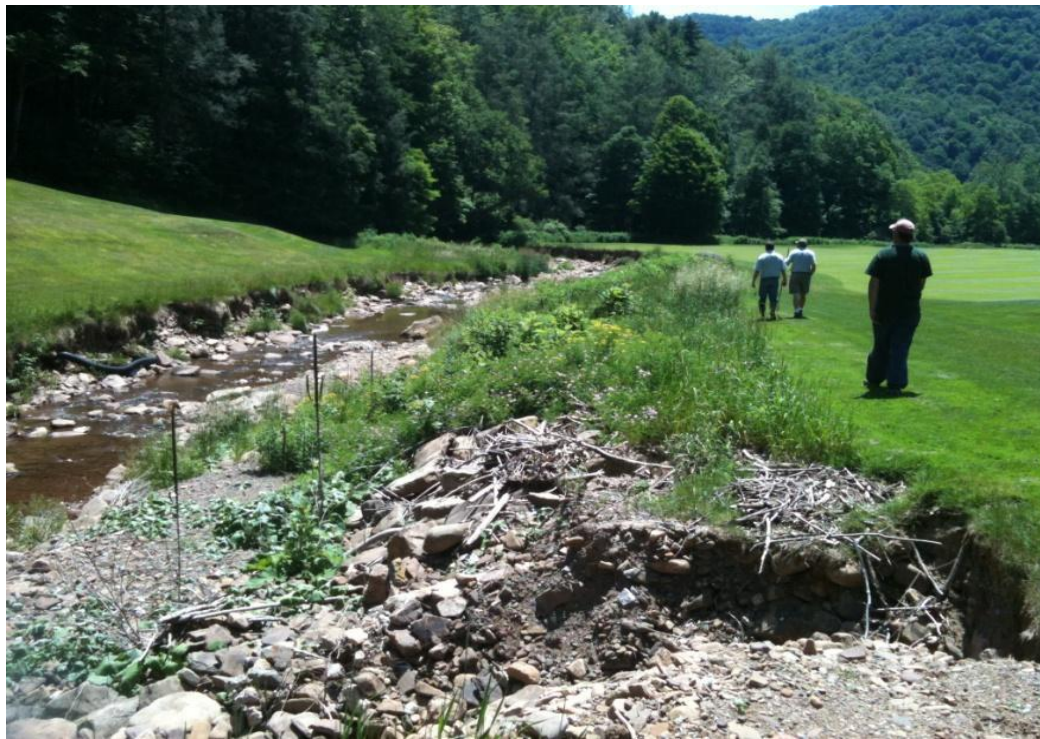
Cup Run flowing through the golf course at Snowshoe Mountain Resort

This project starts below a confined culvert and concrete crossing off the Snowshoe Road towards the golf course in Hawthorne Valley. The stream transects the valley at the end of a golf course fairway when an impaired C4 stream then changes to a G4 stream that is semi-confined by the golf course fairway, as well as the bedrock colluvial hill slope to the east. The stream then flows towards the Snowshoe visitor's center as a D4 stream, where it braids into two forks below where it is again confined by two golf cart crossings. The crossing to the west is similar to the uppermost crossing with corrugated culverts made of concrete fill with stone masonry. This crossing does not allow for sediment and bedload passage, particularly at high flows. Thus, the channel has aggraded and created a new overflow channel to the east. The cart crossing to the east is newly constructed and looks as if the channel may be large in capacity. This site may also aggrade with future floods, but may relieve some of the excess shear stress and bank erosion in the channel to the west.
